Manhole Inspection Summary

Manhole # S13SS1008MH

Insp Date: **11/10/06 11:03 AM**

Location Address: **5115 LEVINDALE RD**

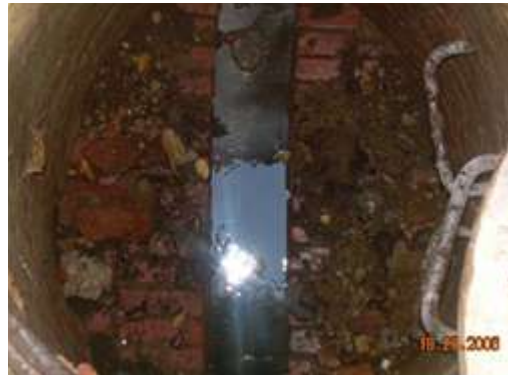
Top View

Evidence of surcharge - Bench debris.
Channel debris.

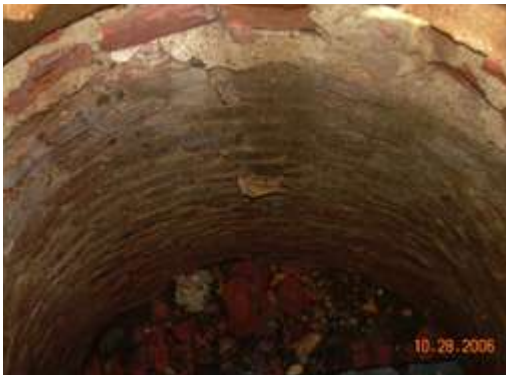
Defect

Frame leaks. Adjustment deterioration
and infiltration. Barrel infiltration.

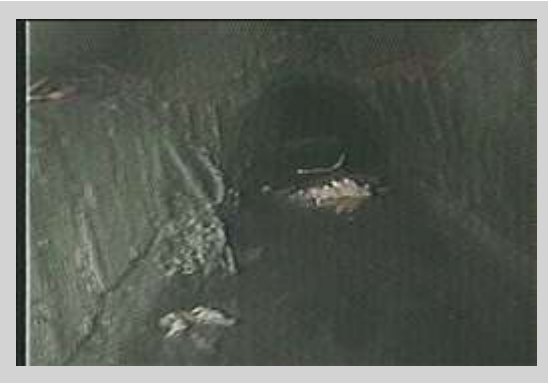
8 in. Circular Gravity Sewer Pipe Out @ 12 O'Clock

Barrel deterioration and infiltration. Channel deterioration and root intrusion.

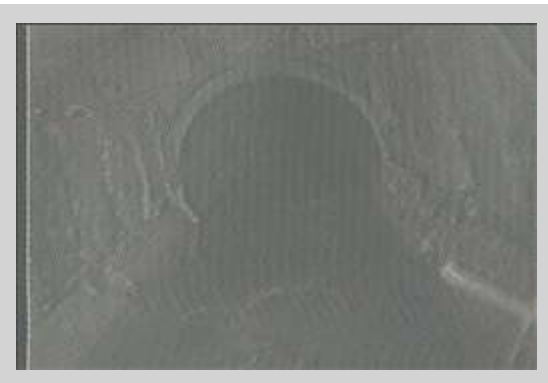
8 in. Circular Gravity Sewer Pipe In @ 6 O'Clock

Channel deterioration.
